RV Inspection Report

Prepared for: Gary Deabler

**Inspection Date / RV Model:
July 30, 2024 / Jayco Eagle 370FBTS**

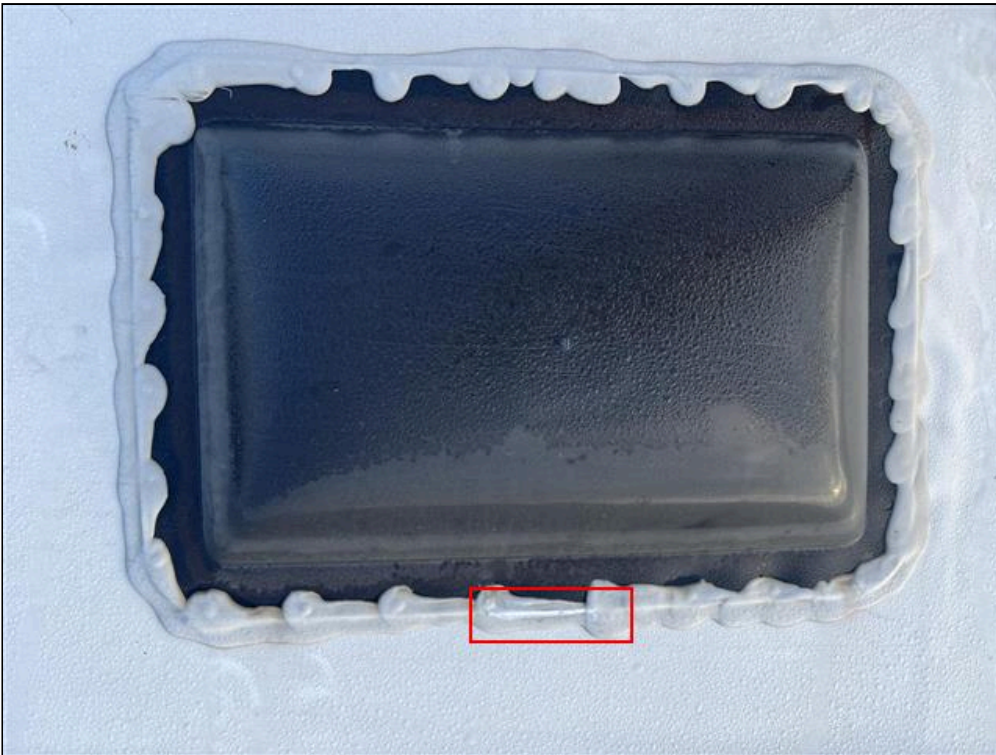
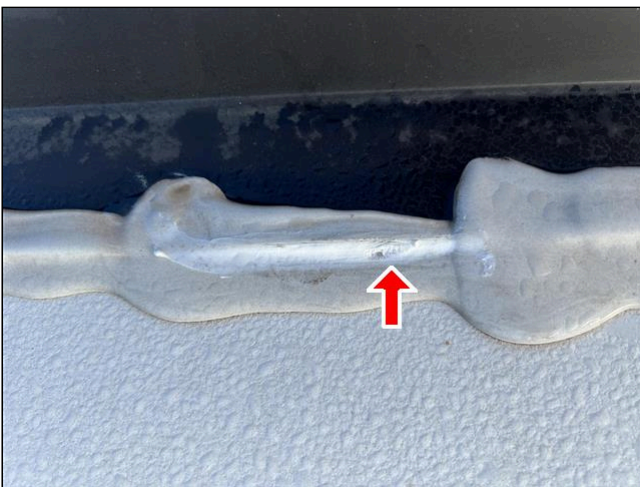
3.10 Skylights - Condition

The lap sealant located at the front streetside skylight was not fully dry and has a hole. This could allow water intrusion. It is recommended that this be further evaluated by a qualified RV Technician.

Streetside Skylight

Right Side of Skylight

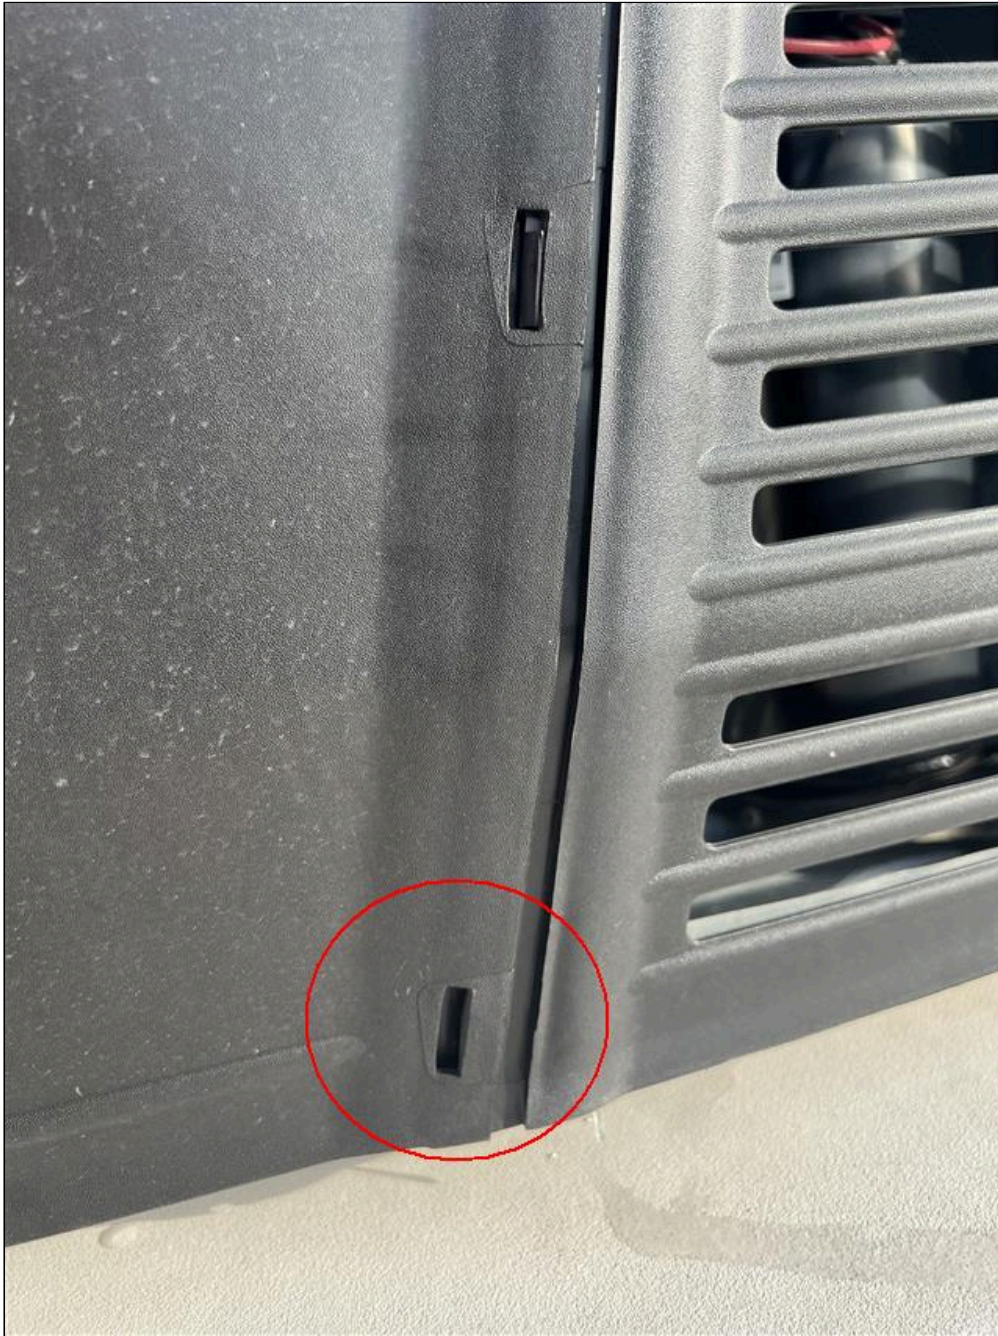
3.15 Rear Air Conditioner - Shroud

The streetside rear AC shroud's bottom clip is not connected. This is a LIFE SAFETY ISSUE. It is recommended that this be further evaluated by a qualified RV Technician.

Streetside Rear AC Shroud

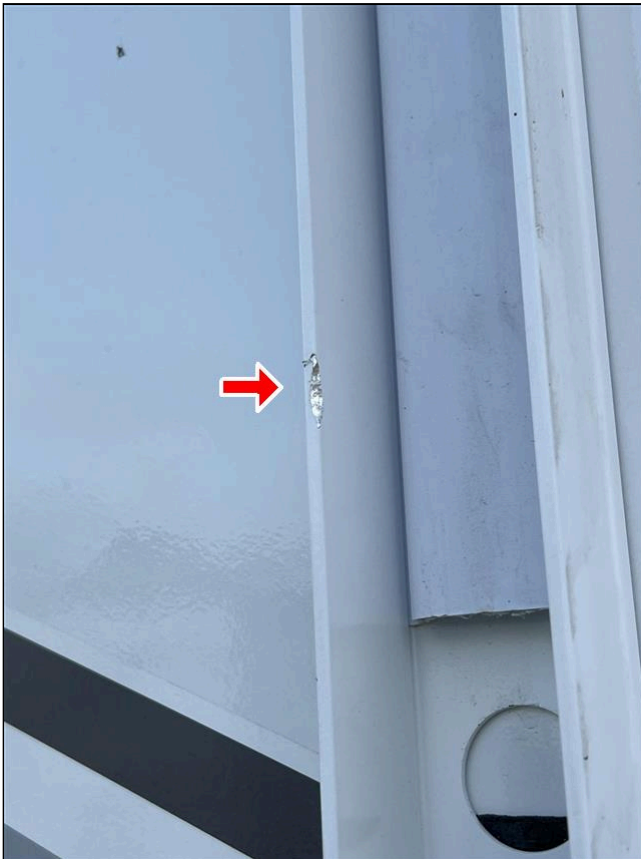
The curbside front awning has an indentation in the frame. It is recommended that this be further evaluated by a qualified RV Technician.

Curbside Front Awning Frame

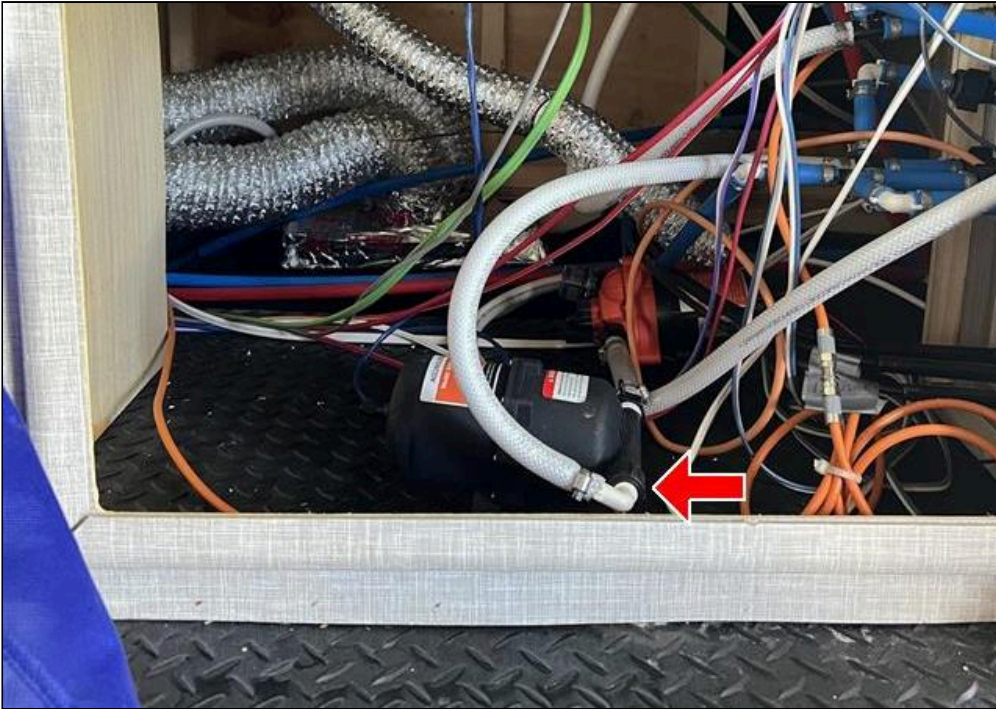
The accumulator attached to the water pump leaks from the fitting. This could allow water intrusion. It is recommended that this be further evaluated by a qualified RV Technician.

accumulator attached to the water pump leaks from the fitting. This could allow water intrusion. It is recommended that this be further evaluated by a qualified RV Technician.

Water Pump Accumulator

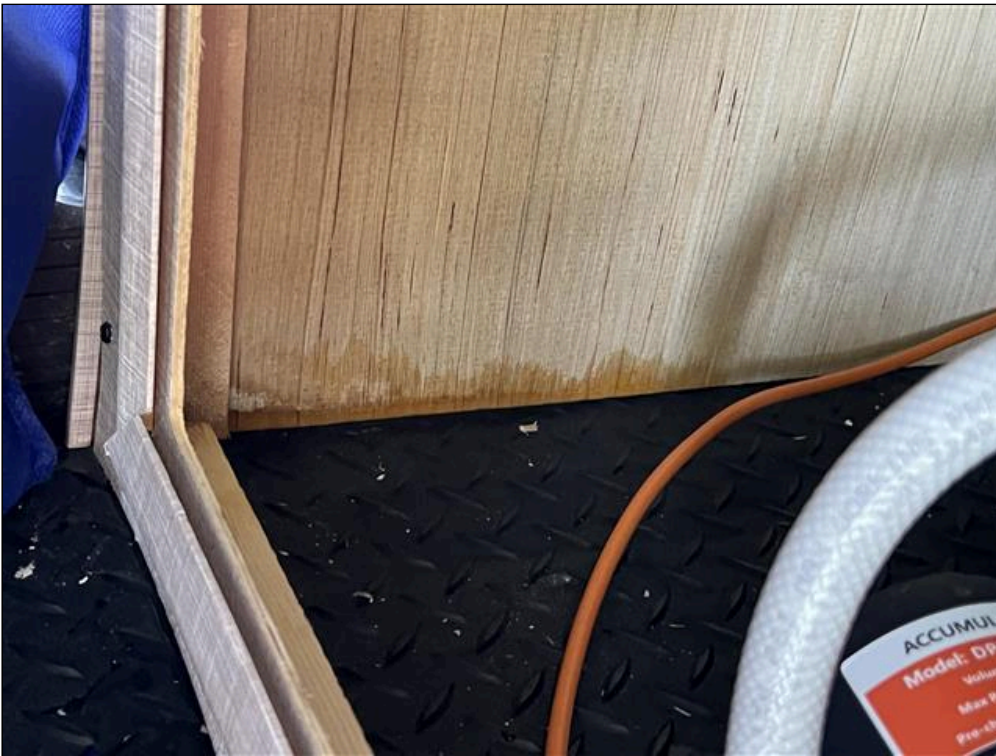
Water intrusion on paneling near Accumulator
