## G & M RV Inspections

| Inspection Type | Buyer: Pre-Purchase Inspection |
| RV Year, Make, Model | 2005 Tiffin Phaeton 40 QDH |

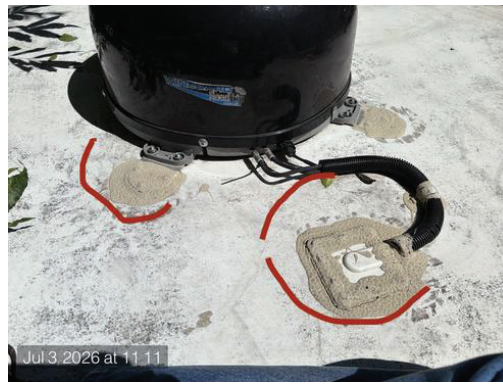
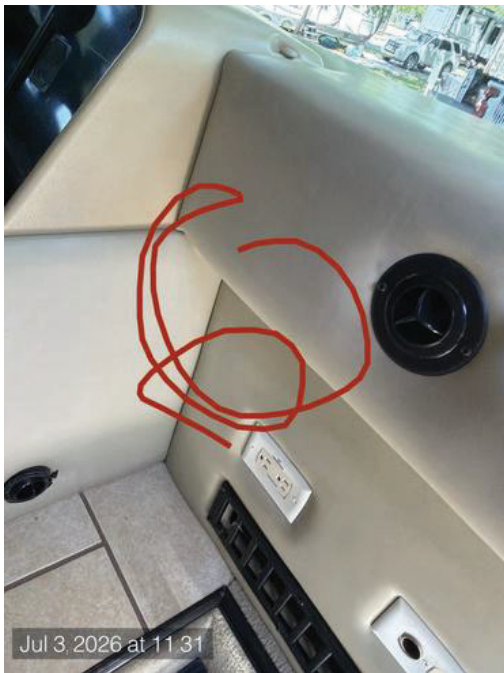
**Roof - Are There Areas of Possible Water Intrusion?**

Yes

Wine guard antenna at two of the bounce and where the wires come through the roof brakes in the sealant. Recommend this be evaluated by RV technician. This could lead to water intrusion.

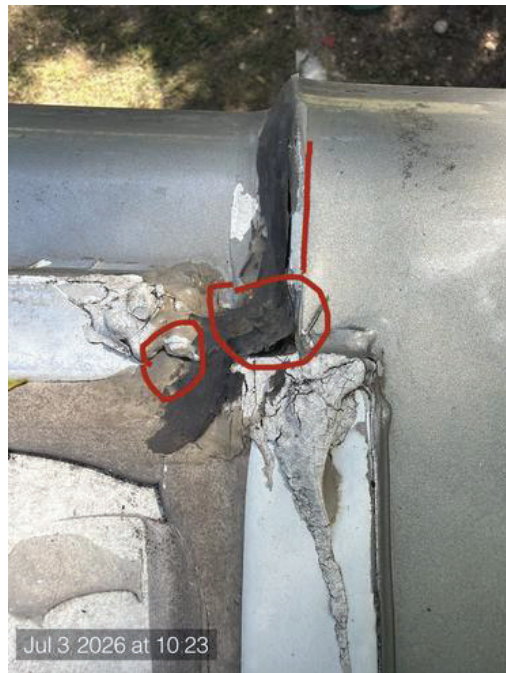
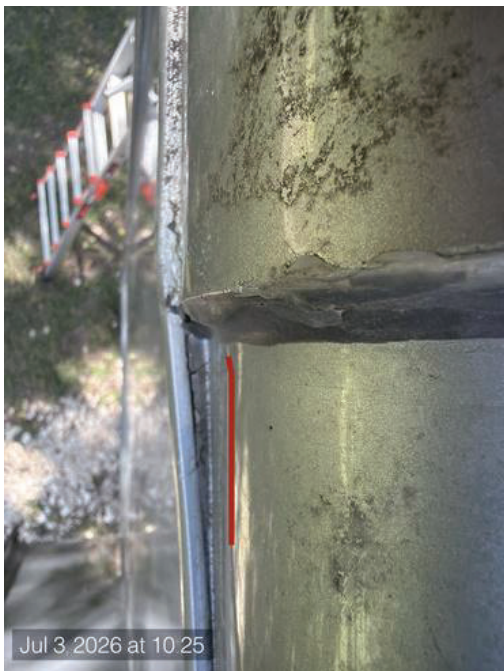
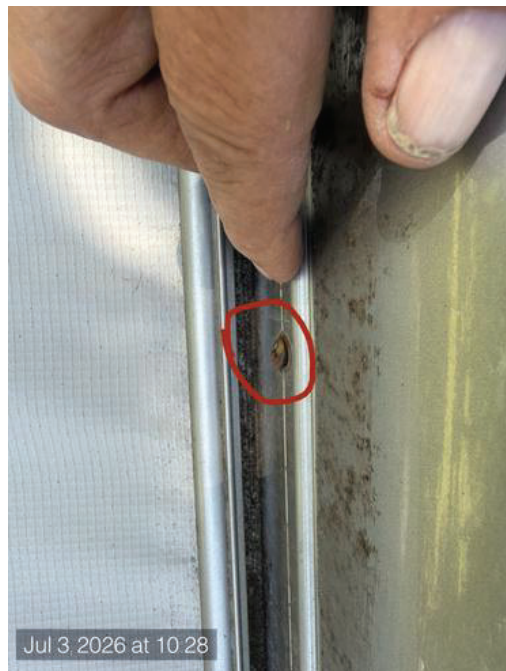
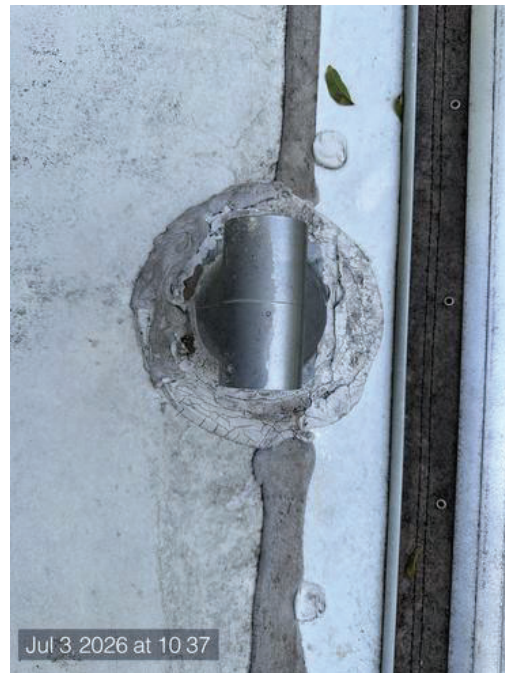
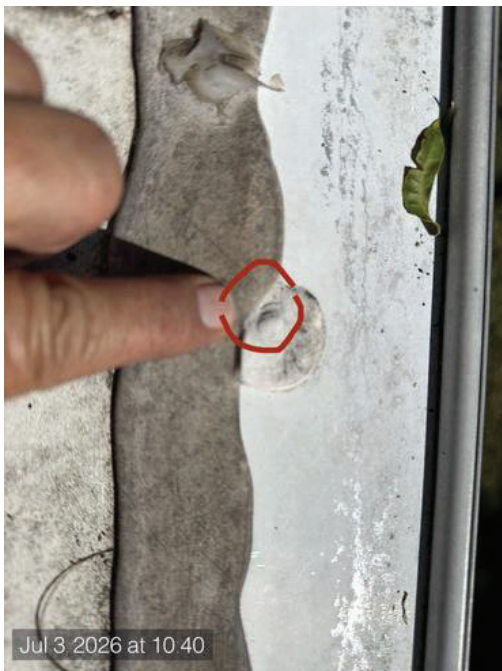
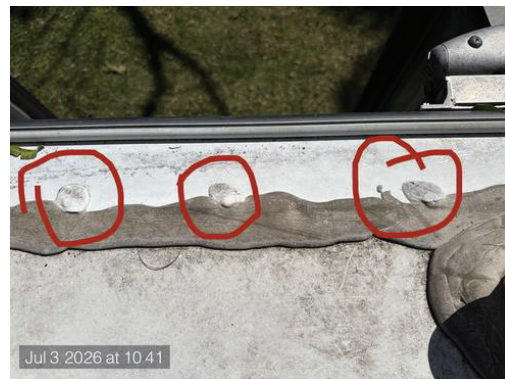
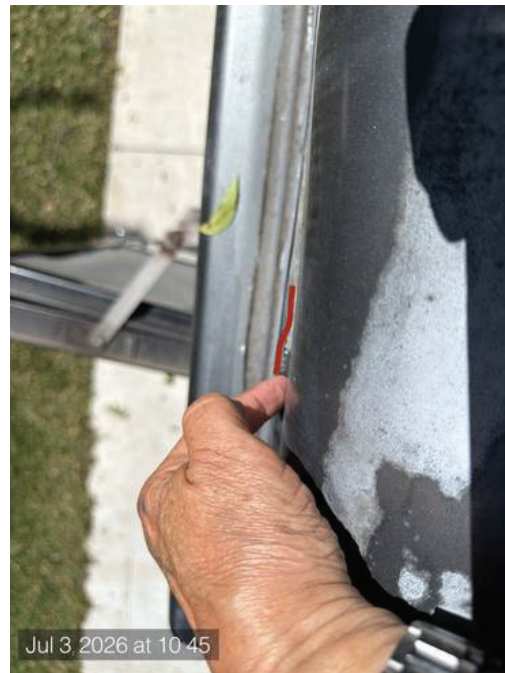
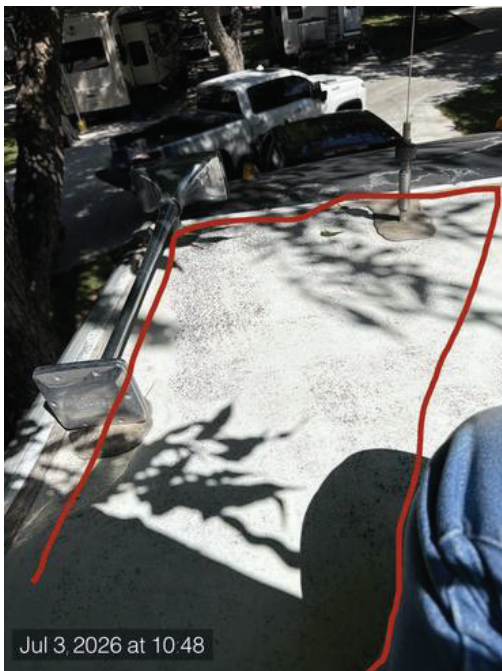
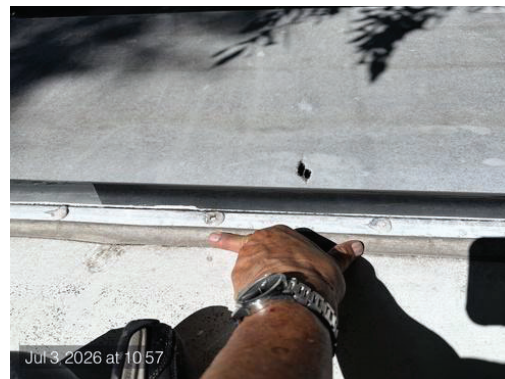
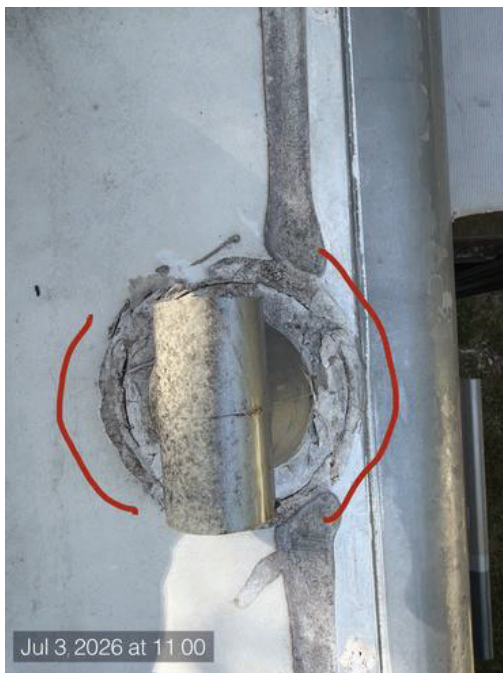
**Rear Cap, Joints & Seals**

Fair - Sealant exhibits minor cracks, holes, and/or is firm

Left rear cap has evidence of possible water intrusion. Recommend this be evaluated by RV technician.

Right side rear cap at the joint several areas of seal and deterioration recommend this be evaluated by RV technician possible water intrusion.

Right side forward of rear cap sidewall were transitions between the roof and the sidewall has break in the sealant. Possible water intrusion recommend this be evaluated by RV technician.

Right side rear of rig above the right side slide out topper trim rail there's a screw that is not fully seated. Shows signs of rust. This could lead the water intrusion. Recommend this be evaluated by RV technician.

Right side of rig forward of right side topper,

Structure for the awning after N, has brakes and seal in several areas. This could lead the water intrusion. Recommend this be evaluated by RV technician.

Vent on roof right side in between the slide outs has numerous areas of crack sealant. This could lead to water intrusion. Recommend this be evaluated by RV technician.

Right side of rig forward portion above the entrance door sealant cracked around 3 screws on the roof. Could lead to water intrusion. Recommend this be evaluated by RV technician.

Right side of rig forward in next to airhorns above the entrance door has two areas of cracks and sealant. This could lead to water intrusion. Recommend this be evaluated by RV technician.

Right side forward end of rig next to front cap side trim rail has cracks and sealant. This could lead to water intrusion recommend this be evaluated by RV technician.

Left side forward end of roof material from the front cap approximately 5 feet going to the rear and by 3 feet going in board roof material loose. I can press down on it. Recommend this be evaluated by RV technician.

Left side of roof trim rail on the roof several screws that breaks in the ceiling. This could lead to water intrusion. Recommend RV technician evaluate.

Left side of roof midway forward of rear slide on the roof, has breaks in the sealant in the vent. This could lead the water intrusion recommend this be evaluated by RV technician.

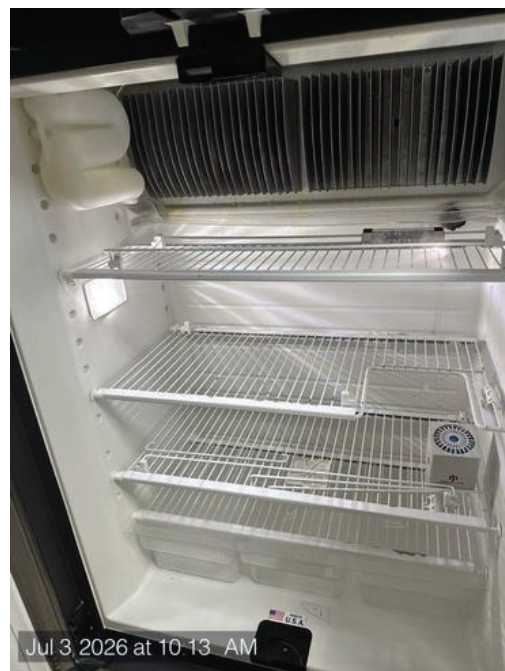
Photo 26

### Refrigerator - Shelves / Door Racks - Visual Condition

Fair

Chips and cracks in door shelves

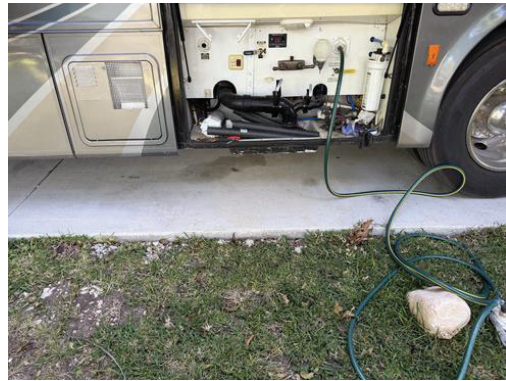
Photo 32

### On-Board Water System - Pressure System Works

No

When filling on board tank, had a major leak Recommend this be evaluated by RV technician.
